Daily Report For 2016-05-23

Metal Bank

Sheetpile Repair
Cottman Avenue
Philadelphia, PA (US)
Report number: 3340011G-12
Date: May 23, 2016 01:15 PM

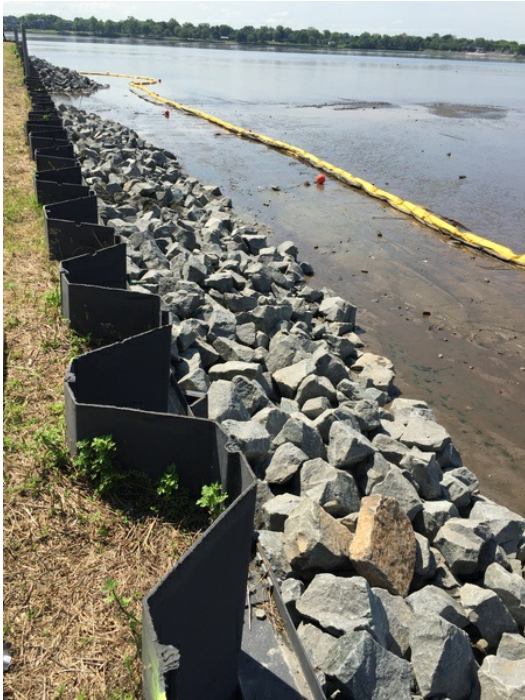
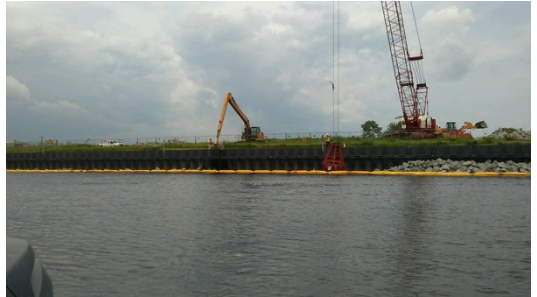
Remark	Description	Assignee(s):
Rip-Rap		
<p>✓ <u>R6 stone placement</u> <u>[3.1]</u> May 23, 2016</p>	<p>(see pics below)</p> <div>

</div> <p>R6 stone placement in Zones 1 and 2 (facing E)</p>	
<p>✗ <u>R6 stone stockpile extends beyond crushed stone pad</u> <u>[7.1]</u> May 18, 2016</p>	<p>CEI continued to address some of this concern today.</p> <div>

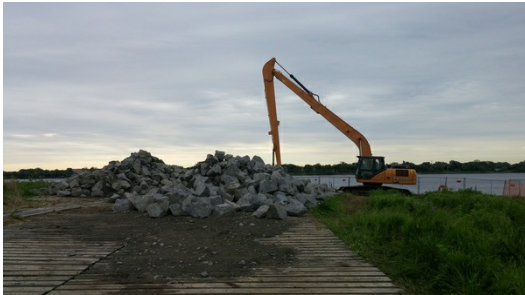
</div> <p>Stockpiled R6 stone on crushed stone pad in Zone 2 (facing South).</p>	<p>John Castellani</p>
General / Other
